⑥ National Dam Inspection Program, Gunter Valley Dam (Inventory Number NDS-PA-323), Susquehanna River Basin, Trout Run, Franklin County, Pennsylvania. Phase I Inspection Report.

GUNTER VALLEY DAM

INVENTORY NUMBER NDS PA-323

PHASE I INSPECTION REPORT

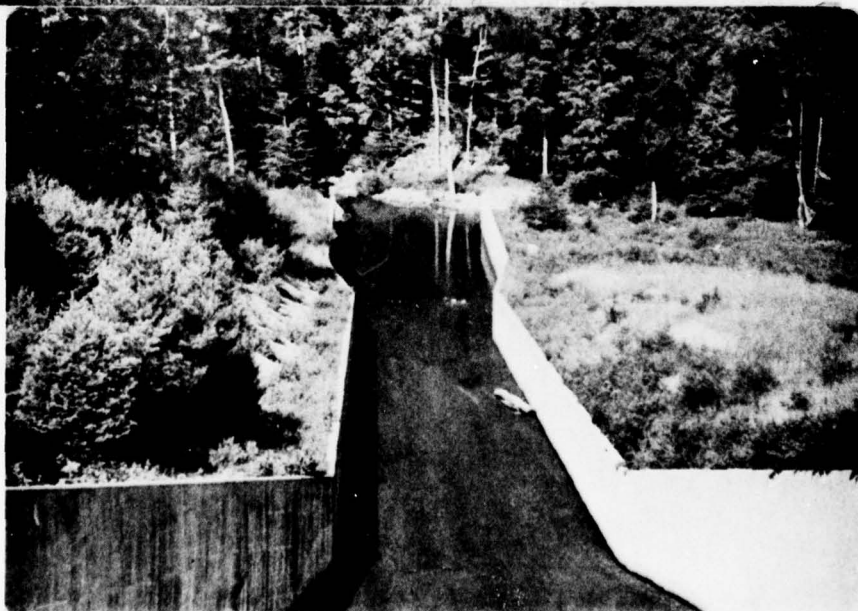
The spillway, located in the left abutment was in good condition. The forebay walls and ogee weir were in excellent shape. Some minor cracking has occurred in the abutment walls under the bridge across the spillway. All joints appeared to be in good condition. The wall in the right spillway wall just below the bridge had deflected slightly (Appendix D, Plate V), but not significant in relation to its height (See Section 6.1.B.2).

Spillway
